Paragon Polymer Consulting, LLC ♦ csmith@paragonpolymer.com
148 Lugnut Lane, Suite 201, Mooresville, NC 28117 ♦ Phone: (704) 728-5879 ♦ Fax: (704) 663-0073

Report Number 2013115
March 7, 2017

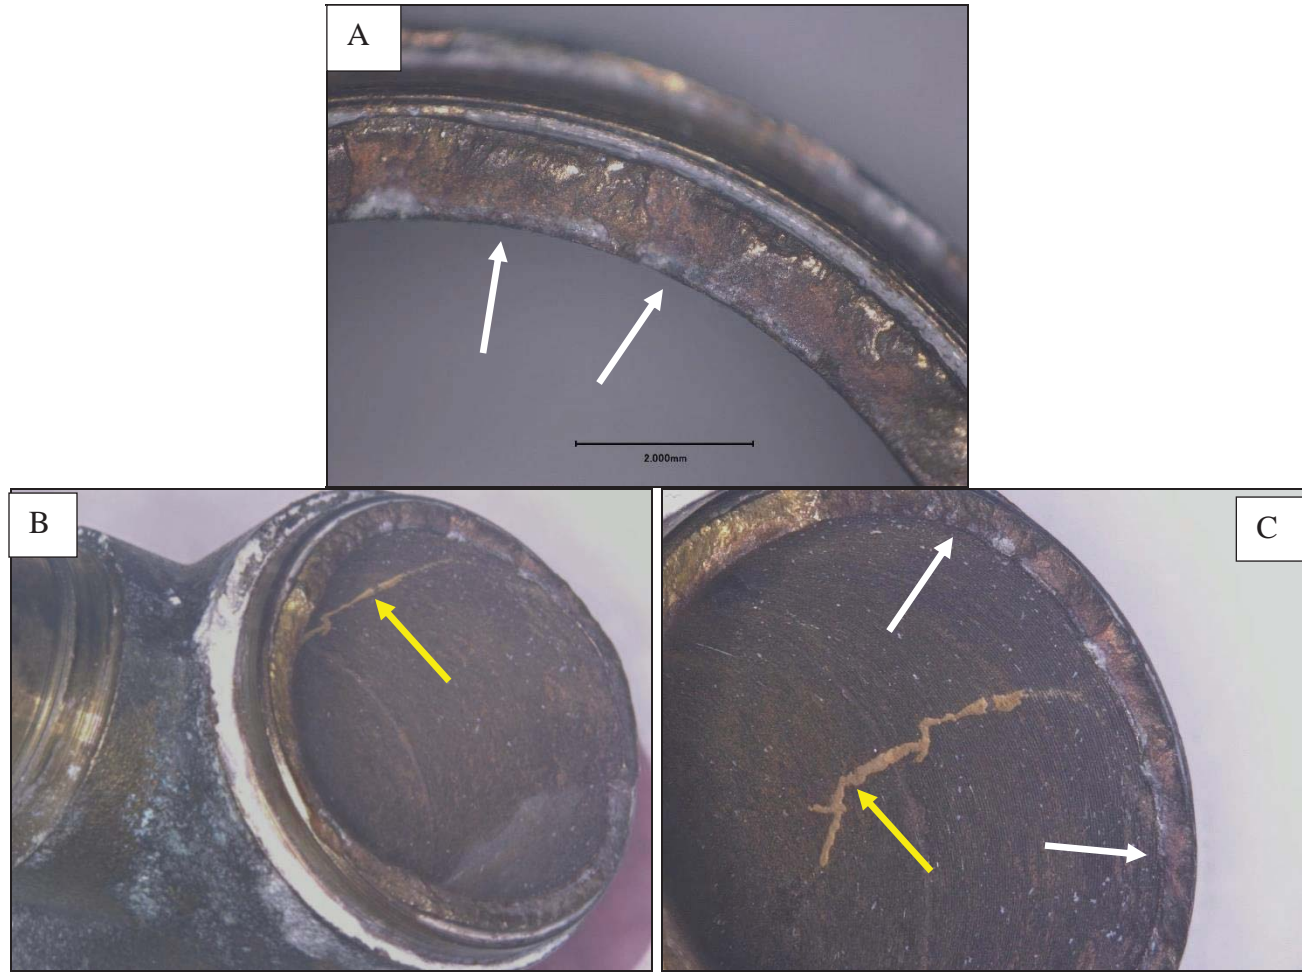
Figure: 20 Brass fitting from the Medders residence (PPX-99) that (A) fractured (white arrows) and (B, C) cracked (yellow arrows) due to stress corrosion cracking. Eventually, the stress corrosion cracks will penetrate the wall of the fitting, allowing water to leak through.

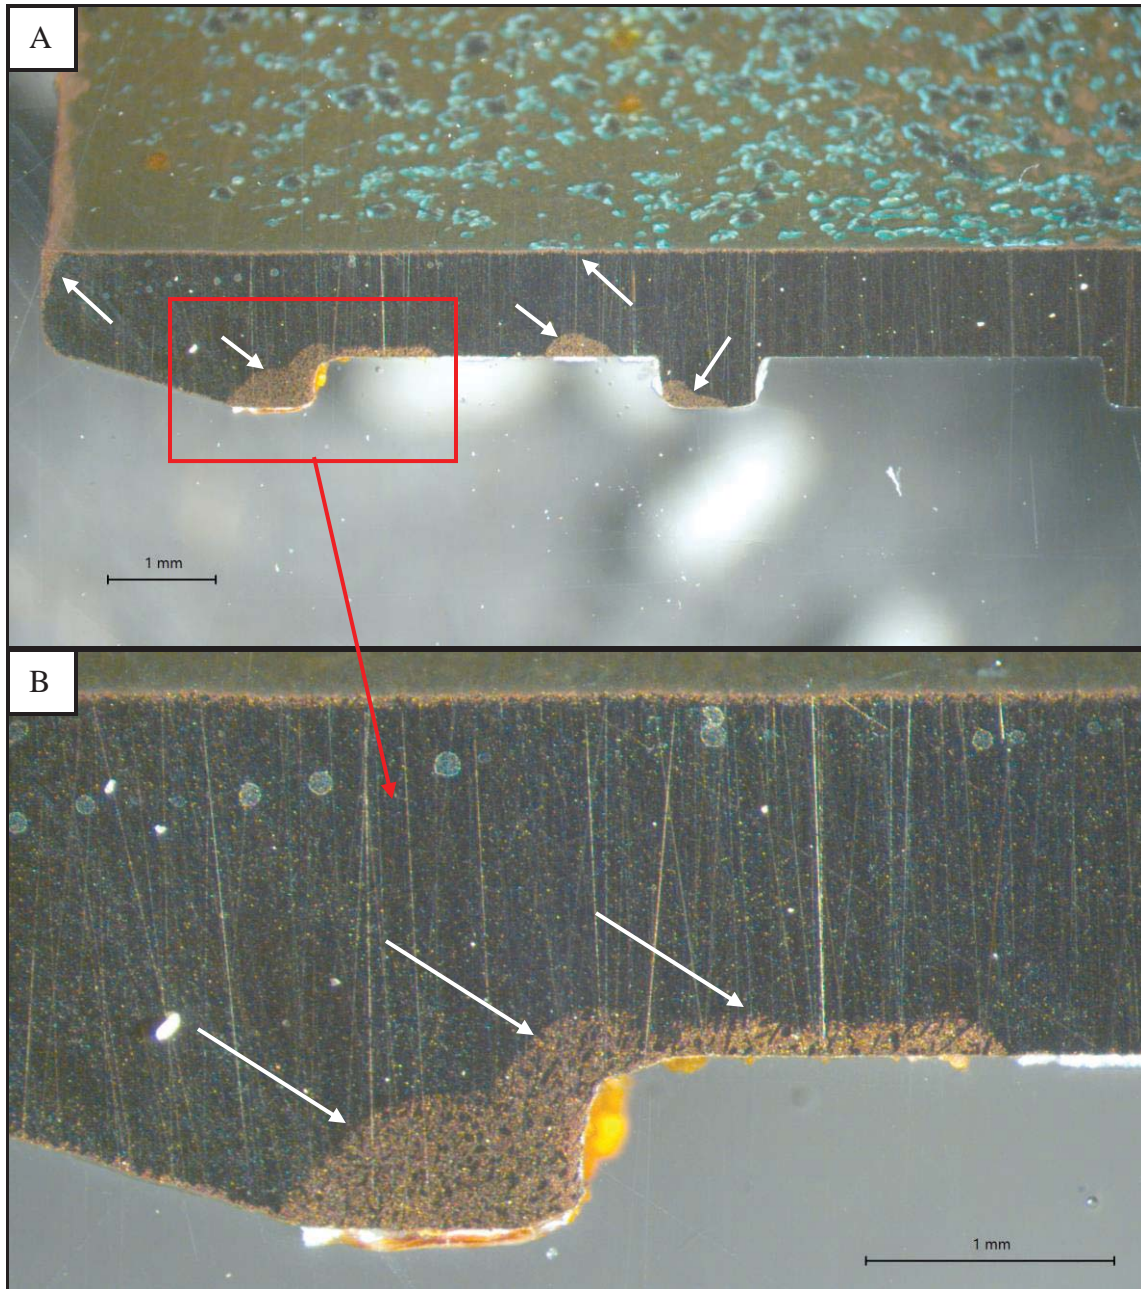
Figure 23: Coarsely-polished metallographic cross-section through the wall of the NIBCO brass fitting associated with Cole PPX-16, shown as viewed using a stereomicroscope. Evidence of dezincification corrosion (arrow) was noted at the exterior, end, and interior of the brass fitting (white arrows). Had the fitting been left in service, these corrosion fronts would have eventually grown through-wall, causing the fitting to leak. The Coles have experienced one fitting leak to date, but that fitting was not available for inspection.
